PHENOMENON OF CORROSION AND THE INDUSTRIAL SAFETY

BENSAADA S., BOUZIANE M.T., MOHAMMEDI F., ACHOUR B.

Research Laboratory in Subterranean and Surface Hydraulics (LARHYSS)
Université of Biskra, B.P 145 RP 07000, Biskra, Algeria

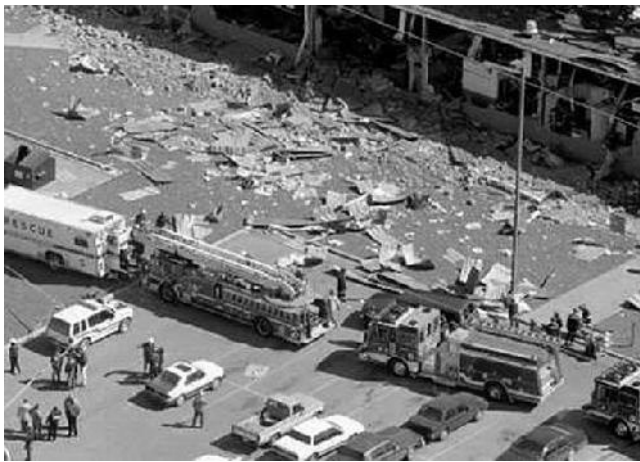
Figure 2 : Overview of the Molding workshop devastated by the explosion, photograph 60 hours after the incident

In 1975, there's been an explosion in a foundry in Scunthorpe in England Appleby-Frodingham Steelworks,(Scunthorpe, England ,1975). Figure 2 shows a general view of the molding shop devastated by the explosion, the picture is taken 60 hours after the incident.

Result: 12 dead over huge property damage

Cause: Corrosion
